Subject: Well Destruction Compliance
ARCO Facility #6061
593 North Mollison Avenue
El Cajon, California 92021
SAM Case No. H07106-001
Well Destruction Permit # LMON102796

DEPARTMENT OF ENVIRONMENTAL HEALTH
MONITORING WELL COMPLIANCE/DRILLING
INSPECTION REPORT

**SECOR
PHOTOGRAPHIC RECORD**

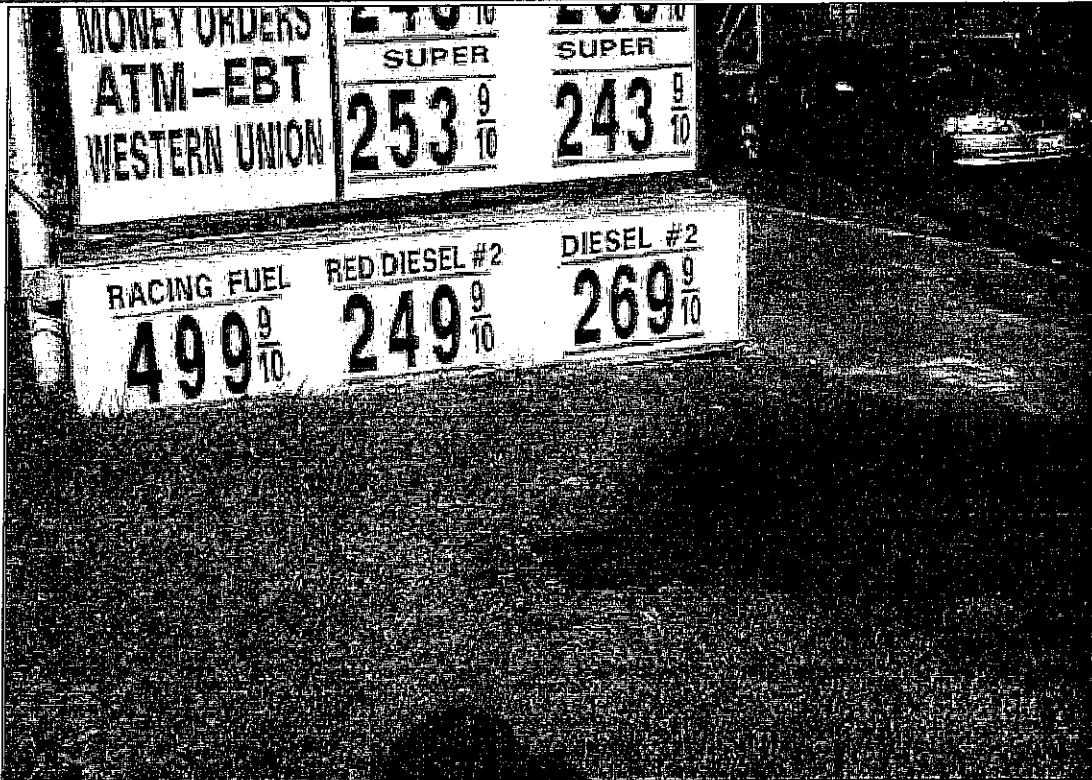
Photograph No. 1

BENTONITE BACKFILL FOR DESTROYED WELL W-9A APPEARS TO HAVE SETTLED, CREATING A SAFETY HAZARD. SEE ATTACHED PICTURE.

Backfilled location of well W-9A.

On behalf of the Atlantic Richfield Company (Atlantic Richfield), SECOR International Incorporated (SECOR) is submitting this response letter to the County of San Diego, Land and Water Quality Division (LWQD) regarding the Monitoring Well Compliance/Drilling Inspection Report dated November 3, 2005 (attached). The LWQD inspection report indicated that monitoring well W-9A was a safety concern due to settling of the well backfill materials. The LWQD therefore requested that the deficiency be corrected using soil to backfill the hole. On December 5, 2005, SECOR personnel backfilled the area of W-9A with approximately 16 quarts of soil, moistened the soil with water and tamped it down. Photographs of W-9A with the repairs are attached.

1. PLACE SOIL IN MW-9A FROM THE DEPTH OF THE HOLE TO THE GROUND SURFACE TO MATCH THE SURROUNDING AREA. ENSURE SOIL IS COMPACTED SUFFICIENTLY THAT IT WILL NOT PRESENT A TRIPPING HAZARD.

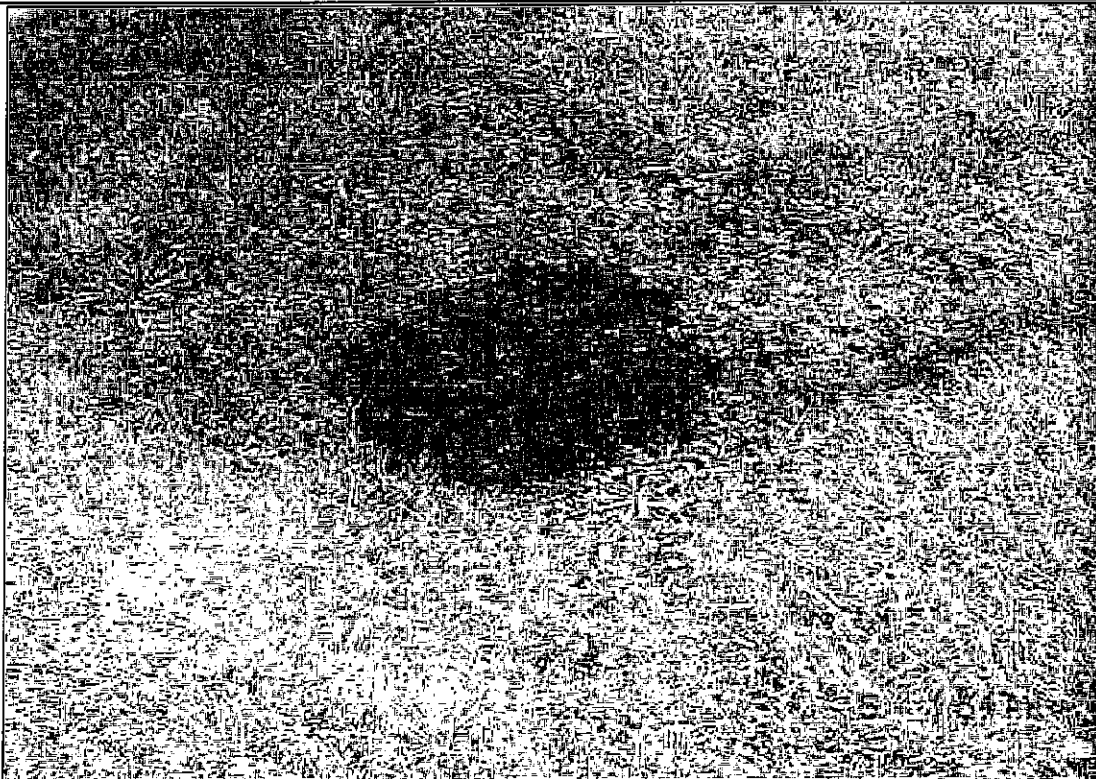
Photograph No. 2

Close up view of backfilled location of well W-9A.
